Case Study – Analysis of Fractured Bottoms of Paint Cans

Packaging Technology Center – CETEA, Institute of Food Technology – ITAL, Campinas, Brazil

The purpose of this study was to determine the root cause of fracture in bottoms of rectangular 18 l cans of water-based acrylic paint used in the building industry and sold in retail. Following a change in the formulation of the inner coating of the cans, fractures developed in the double seams of the can bottoms, which were made of electrolytic chromium/chromium oxide-coated steel internally coated with pigmented varnish (epoxy melamine). Slight differences were detected in the infrared spectra of both the new and altered varnishes produced with the same base resin. The microanalysis of paint samples collected from both damaged and undamaged cans revealed presence of practically the same elements. The evaluation of the varnished surface of can bottoms revealed depressions in the varnish of all cracked bottoms, inclusive in the curved areas and bottom hook of the double seam, which did not get in direct contact with the paint. However, depressions were not detected in undamaged can bottoms. The metallographic analysis did not reveal

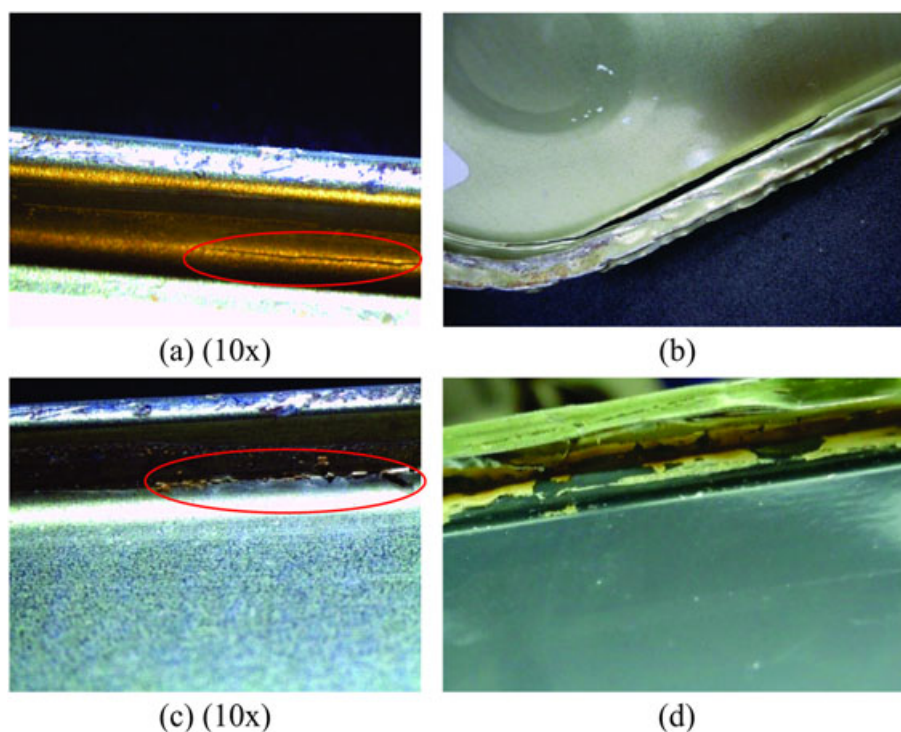
Figure 1. Photographs taken of an area of a cracked can bottom: (a and b) outside and (c and d) inside the damaged can.

Figure 1 shows photographs of cracks at the bend of the bottom double seam. Fracture/cracking is seen in a mechanical channel-shaped deformation at the bottom.

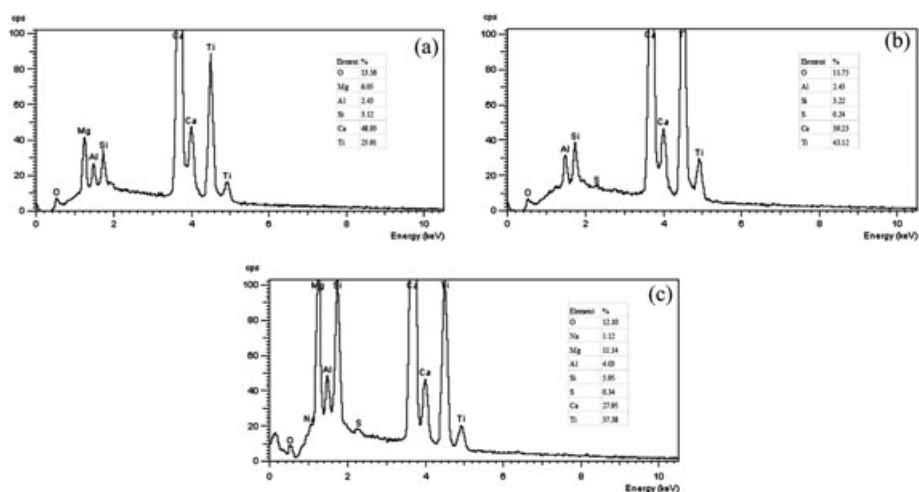
Figure 2. Microanalysis spectra representative of the two samples of paint: (a and b) paint from the undamaged can and (c) paint from the damaged can.

According to the spectra shown in Figure 2, except for sodium, which was seen only in the paint from the damaged can, the same elements were detected in both samples of paint, including sulfur, but with different intensities. The intensities of the elements magnesium and silicon are higher in the paint from the damaged can.

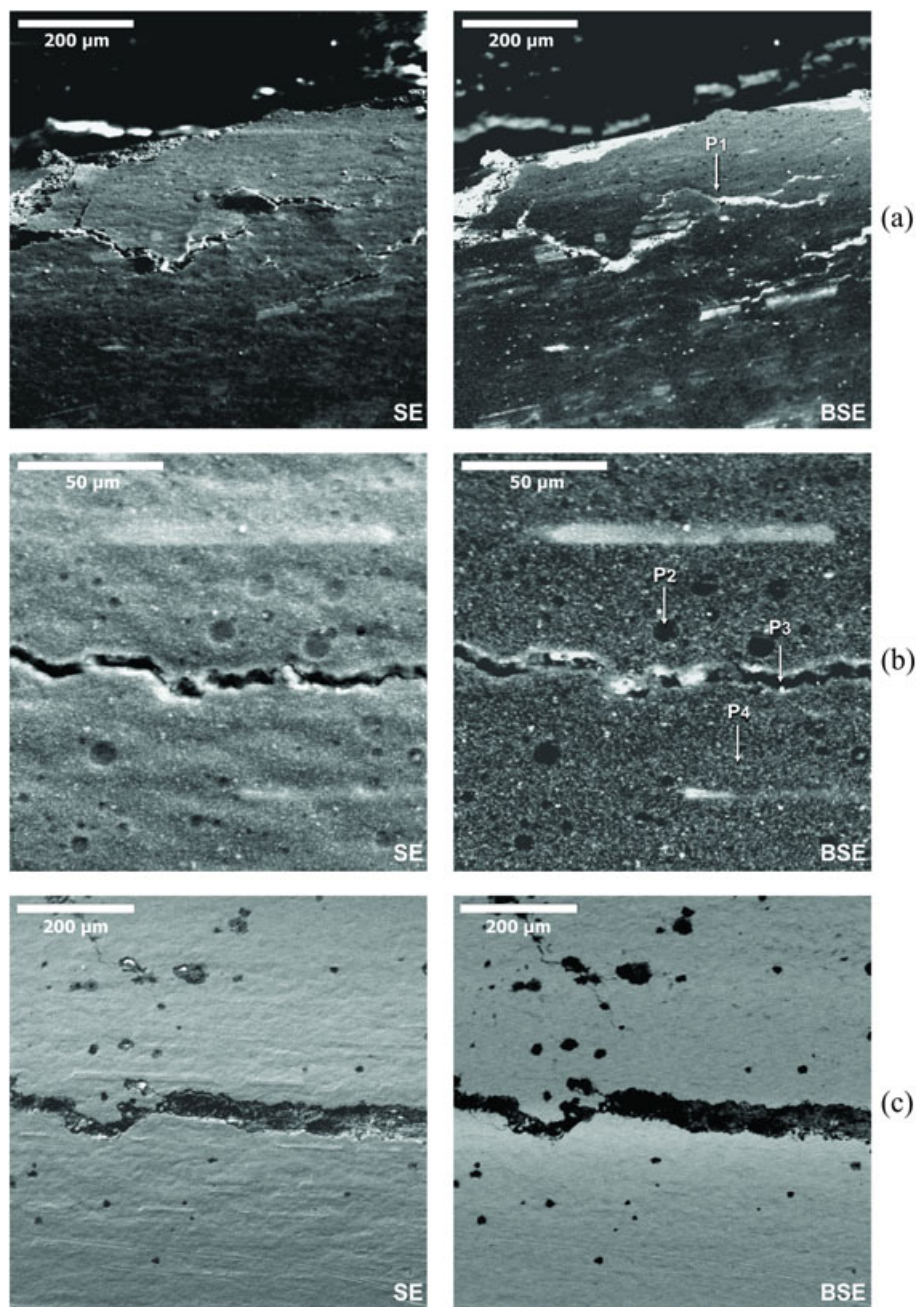
Figure 3. Microphotographs of the specimens collected from a cracked can bottom: (a) crack at the double seam bend, (b) surroundings of a fissure in the coating with defective spots and (c) area of Figure 3b after the coating was removed. BSE, backscattered electron; SE, secondary electron.

Cracks that developed right in the double seam bend are shown in Figure 3a. Figure 3b, taken with larger magnification near a fissure in the coating close to another cracked area, shows uneven surface relief of the varnish film in the form of depressions. Figure 3c shows that, below the varnish film removed from the area around the fissure, the metal is intensely corroded, although it is not cracked yet. It can also be observed that corroded regions coincide with the depressions on the varnish film (Figure 3b and c).

The results of the microanalysis of the positions specified in Figure 3, shown in Table 1, reveal marked presence of iron at position P1 close to a cracked area. Sulfur and phosphorus were also noted at this position. Besides the metal and paint/varnish components, sulfur, phosphorus and chlorine were also detected at the positions P2, P3 and P4, taken from the varnish film in fissured and depressed spots. The source of sulfur can be either the steel or the wall paint, along with chlorine. Chlorine and sulfur are corrosion-accelerating agents on the steel sheet. Phosphorus concentrations above the specified maximum limit can affect steel ductility and toughness, thus increasing brittleness. Sulfur as a residual or alloying element above the specified maximum limit largely tends to segregate and occurs in steel particularly in sulfide inclusions.¹¹ While the microanalysis provides values for relative concentration, these elements appear in higher concentrations in the positions evaluated and may have weakened the steel, although the steel composition was in conformance with the specification.

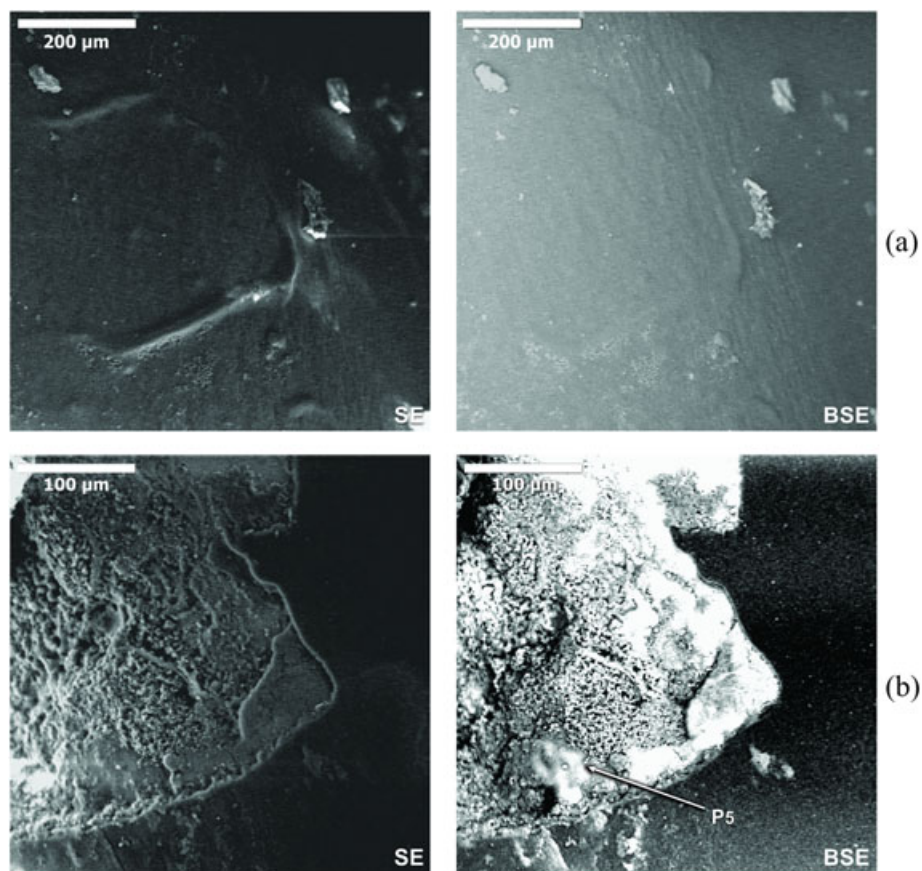
Figure 4. Microphotographs of the surface of the specimens collected from can bottoms with no cracking: (a) area of the double seam bend showing wrinkled varnish and (b) exposed steel in the double seam. BSE, backscattered electron; SE, secondary electron.

The varnish in the radius of the double seam countersink of undamaged can bottoms was somewhat wrinkled (Figure 4a), with wrinkled spots extending to the inside part of the double seam (Figure 4b); however, no cracks were seen. The spectrum of Figure 5 confirms steel exposure in the spot, because iron element is detected more intensely than in the undamaged area, and chromium element is not detected.

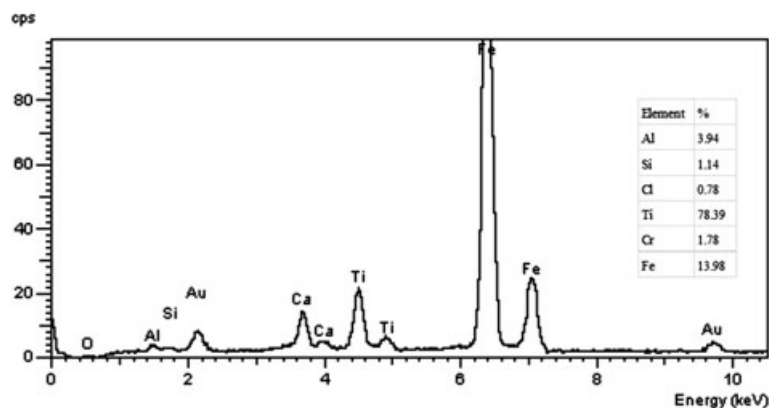
Figure 5. Microanalysis spectrum representative of the assessment conducted in the area shown in Figure 4b (P5), obtained through the light element window.

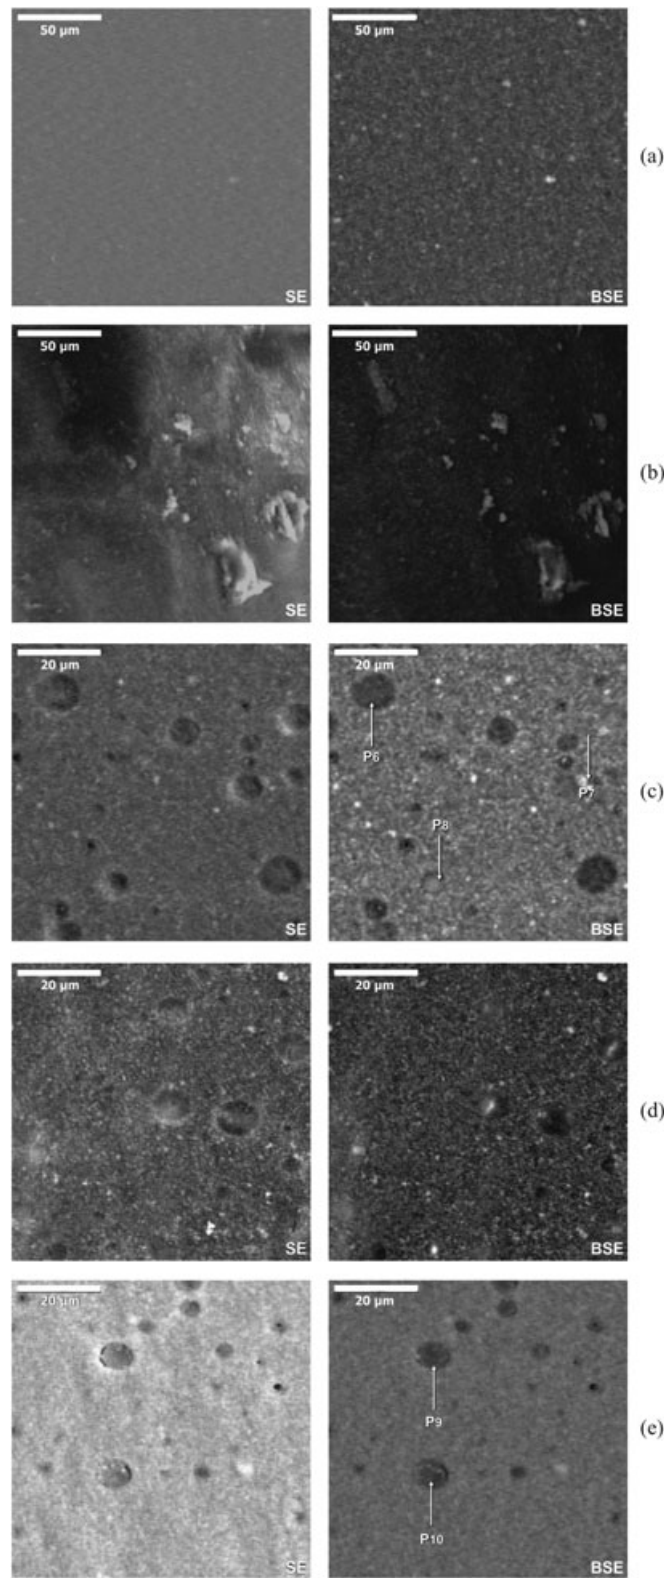
Figure 6. Microphotographs of the surface of a specimen collected from a can bottom: (a) flat area of a can bottom with no cracks, (b) area of double seam bend with no cracks, (c) flat area of a cracked can bottom, (d) area of the double seam bend of a cracked can bottom and (e) flat area of a cracked can bottom. BSE, backscattered electron; SE, secondary electron.

Figure 6 shows microphotographs illustrating that there are no depressions in flat areas of the varnished surface of uncracked cans (Figure 6a) nor in the area of the double seam bend (Figure 6b). However, there are depressions in these two areas in cracked can bottoms (Figure 6c–e) that have a varnished surface with heterogeneous topography.

P6, P7 and P8 positions in areas with depressions shown in Figure 6c display large presence of iron, followed by titanium and chromium. This indicates that the metal was exposed in the spot, as shown

by the results of microanalysis in Table 2. In P9 and P10 positions shown in Figure 6e, also in depressions, the predominant element is titanium, followed by iron and by other elements belonging to the varnish, to the paint and to the metal sheet, such as chromium. The intense presence of titanium in the spot with depression may be related either to contamination of the area by the paint in the can or to uneven distribution of titanium in the can varnish.

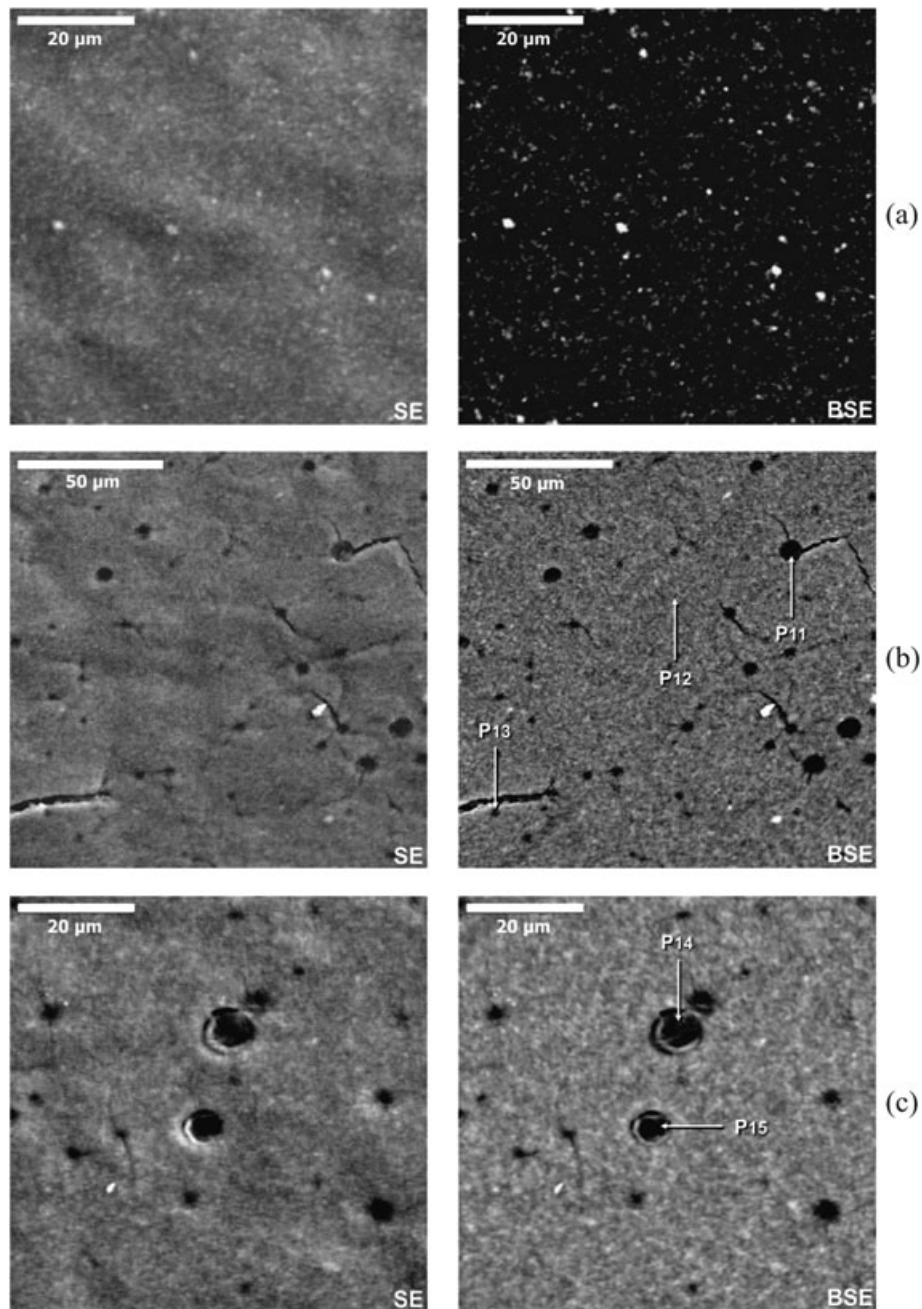
Figure 7. Microphotographs of the bottom hook collected from double seams of can bottoms that did not get in direct contact with the paint: (a) undamaged and (b and c) damaged. BSE, backscattered electron; SE, secondary electron.

Specimens collected from double seam hooks of can bottoms that at first had not contacted the paint were also assessed via MEX/EDX. There were no changes in the varnished surface of the undamaged sample (Figure 7a). However, depressions and fissures could be seen on the surface of the varnish collected from the damaged sample (Figure 7b and c). It must be noted that these failures cannot have

been the consequence of direct contact of the varnish with the paint, because the area under analysis was located inside the double seam.

These defects can be associated to changes in coating composition, which formed these micropores during the curing process, because the bottoms failed during a specific period.

The results of the microanalysis shown in Table 3 reveal high relative concentrations of titanium (both in undamaged areas and in depressions and/or fissures) and iron. Such iron concentrations appear in different relative percentages in comparison with titanium, depending on the spot being analysed. They are lower in undamaged areas than inside the pits. This observation suggests either metal exposure or thinning of the varnish layer inside the depressions in the varnish film. This allows the beam of electrons to penetrate the metal sheet even deeper, resulting in higher intensity of iron. Detection of chromium only in defective spots of the varnish is also indicative of metal exposure or thinning of the varnish in that specific spot.

Punctual corrosion developed in these defective spots as a result of the contact of the exposed steel surface with the paint, which has components that develop corrosion (pH, carbonate, amine and sulfur). The pits on the steel surface, in combination with tensile stress in the double seam area caused by the weight of the paint (static loading) and by possible residual stress in the metal due to the metal forming process, led to fracturing of bottoms of paint cans as a result of development of SCC.

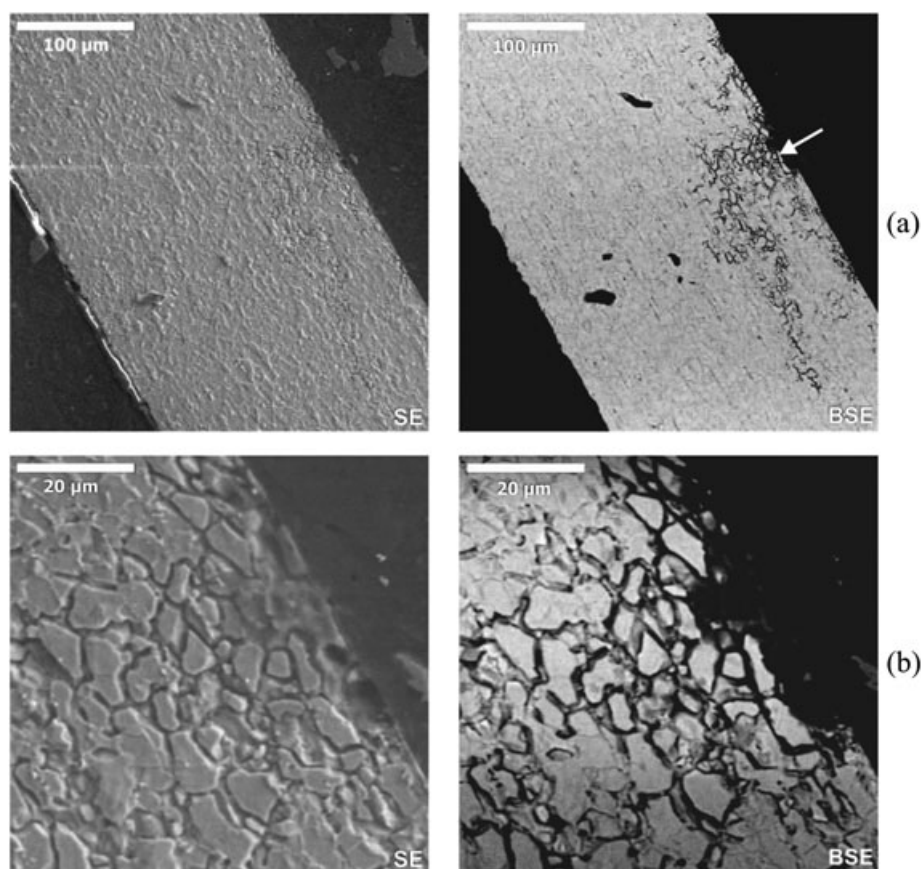
Figure 8. Microphotographs of the area of the radius of the double seam countersink of a cracked can bottom, in a spot with no full rupture of the material, illustrating (a) onset of intergranular corrosion and (b) detail of grain disintegration. BSE, backscattered electron; SE, secondary electron.

Figure 8 shows SEM microphotographs of the cross section of the double seam chuck wall radius in the inner side of a cracked can bottom in an area close to the crack but before rupture of the material. Figure 8a shows the onset of intergranular corrosion. Figure 8b shows grain disaggregation and development of SCC on the radius of the double seam countersink.

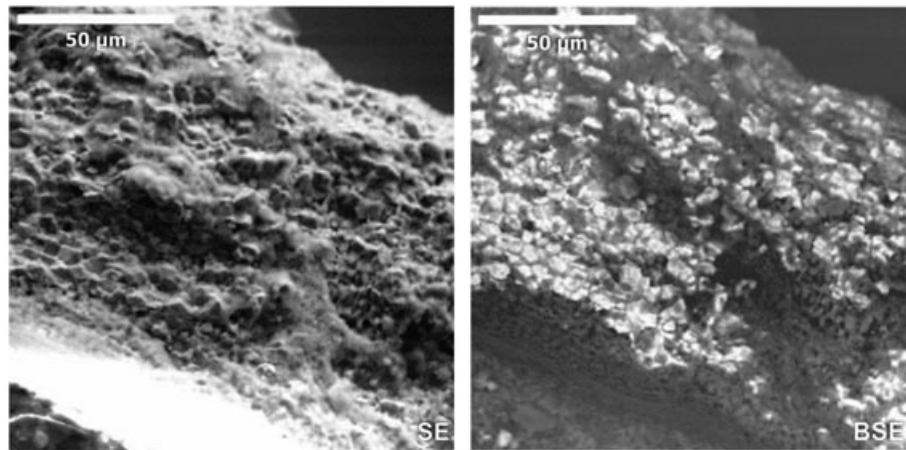
Figure 9. Microphotographs of the longitudinal section of a fracture. BSE, backscattered electron; SE, secondary electron.

Figure 9 shows SEM microphotographs of the fractured/cracked surface displaying intergranular morphology.

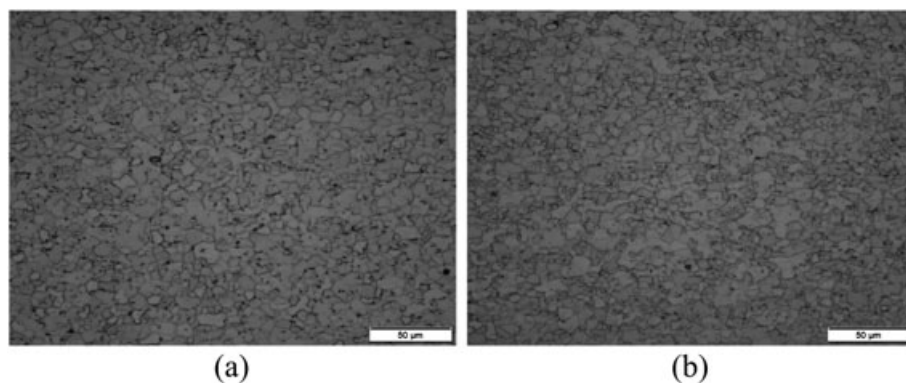
Figure 10. Micrographs taken with an optical microscope of the specimens collected from can bottoms: (a) cracked and (b) uncracked, after preparation of the surface.

Figure 10 shows microphotographs taken with an optical microscope of specimens collected from cracked and uncracked can bottoms during metallographic analysis. This analysis detected isolated carbides dispersed within the matrix of ferrite grains in both metallic materials. No significant differences from the microstructural point of view were found between them.
